The Impact on Great South Bay of the Breach at Old Inlet
Charles N. Flagg
School of Marine and Atmospheric Sciences, Stony Brook University

This is the sixth in a series of reports describing the evolution of the breach at Old Inlet and the impact it has had on water level and water properties in Great South Bay. This report also updates the aerial surveys and includes all the observations of water level and salinities through January 28, 2013. Since the last report, we have retrieved the sensor at Barrett Beach, which completes the analysis of water level data through the time of super storm Sandy, Figure 1. All the sensors have been redeployed while the Bellport sensor is reporting its data realtime through the GSB Observatory website (<http://po.msrc.sunysb.edu/GSB>).

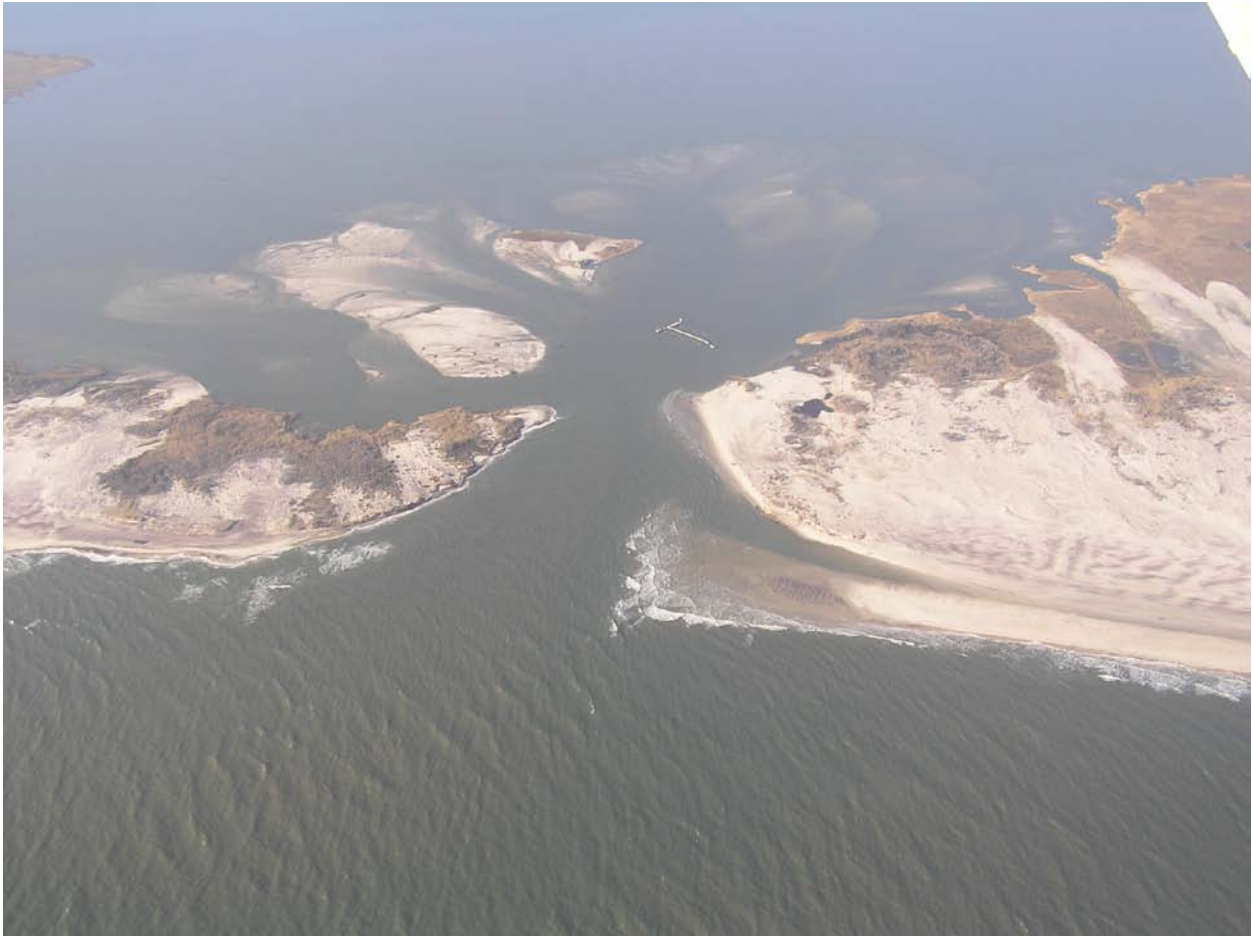
Figure 2. Aerial photo taken by J. Flagg and C. Flagg on January 6, 2013.

The latest aerial overflight took place on January 27th at noon eastern standard time. To illustrate the ongoing evolution of the inlet, a photo from the previous flight on January 6th is shown in Figure 2. The January 6th photo shoot took place shortly after the two storms that occurred in late December. At that time, an offshore bar had formed along the eastern beach and moved onshore creating a series of ridges and runnels that eventually connected to the ebb shoal. The ridge/runnel system extended all along the beach to the east and so was not inherently associated with the inlet morphological dynamics. As the offshore bar moved onto the beach, it cut off the east channel and forced all the tidal flow to use the west channel, causing it to enlarge and move into the center of the inlet. The ebb shoal delta that had been prominent in earlier photos had eroded away. Significant deposition had occurred along the eastern edge of the inlet, especially at the northern end, while along the western edge of the inlet, there had been considerable erosion with the shoreline moving up to the scrub line.

In the three week period between the photos in Figure 2 and Figure 3 (1/6-1/27), there has been a period of strong, but not storm, winds out of the west, and in the last week the weather has been cold enough to freeze much of eastern Great South Bay. The evolution of the inlet on the bay side was not that extensive, but there were significant changes at the ocean end, Figure 3. The offshore bar that was in the process of moving shoreward on January 6th has completed that process, and the sand associated with the ridge and runnel system along the eastern beach has completely joined the beach. The sand, which was part of the offshore bar that extended into the inlet, has attached itself to the eastern edge of the inlet, while the sand at the northeast corner of the inlet has disappeared. The ridge and runnel system that had been prominent along the eastern beach has now formed along the western beach and extended into the inlet forming a new ebb tidal delta, while the main channel appears to have shifted slightly to the east as a result. And there has been some additional erosion of the dune to the west.

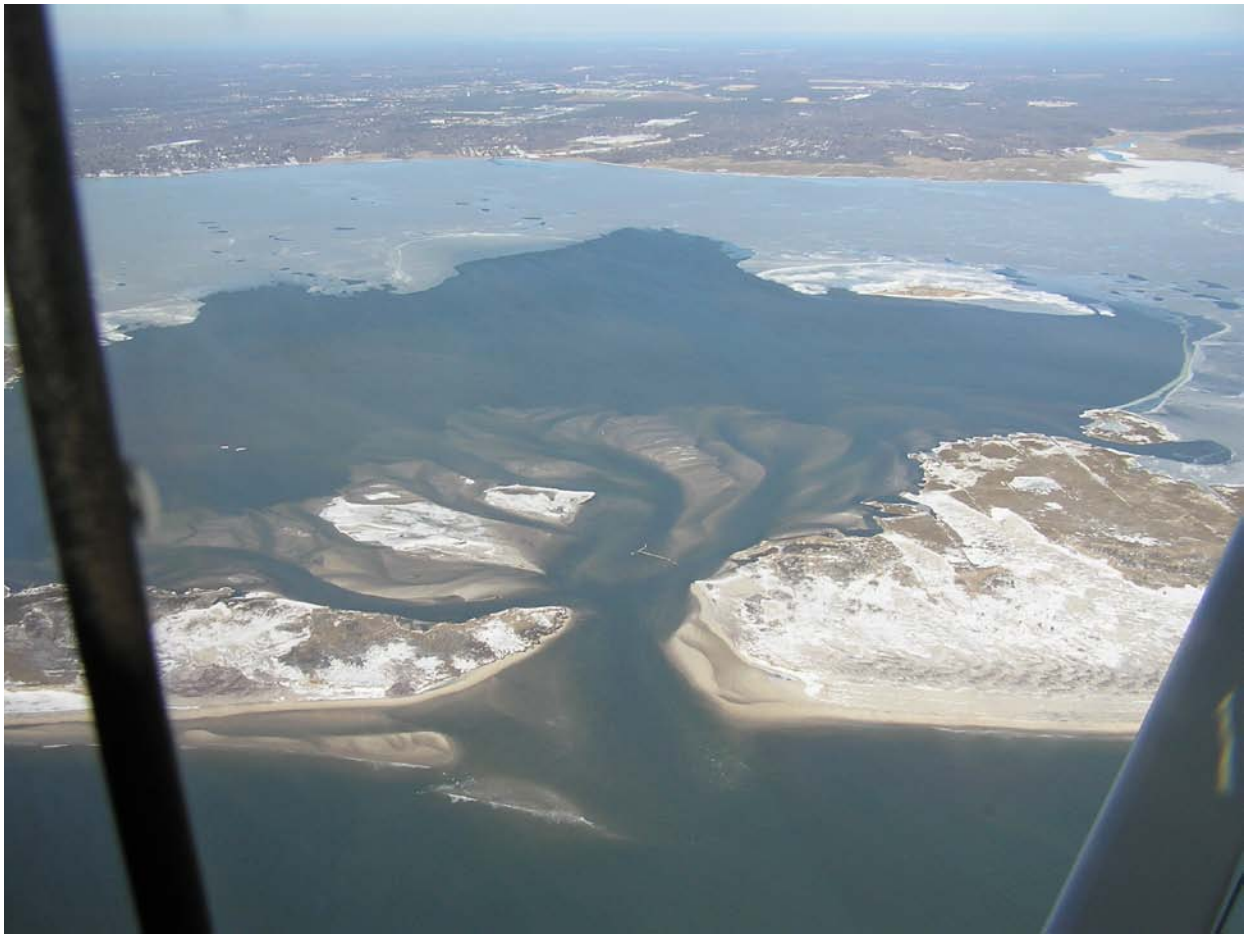
Figure 3. Aerial photo taken by C. Flagg and D. Richards on January 27, 2013.

The water was extremely clear during this latest over flight, which permits a good view of the channels in the back bay area. These channels show up quite prominently in Figure 3 as does the extensive area of sand deposited in the Bay as a result of the inlet formation and overwashes to the east. It now appears that there is one major channel to the west close along Fire Island and two possibly shallower channels to the northeast past Pelican Island. There had been snow during the previous week so anything that shows up white is clearly above the high tide line and that includes a number of portions of the new sand islands.

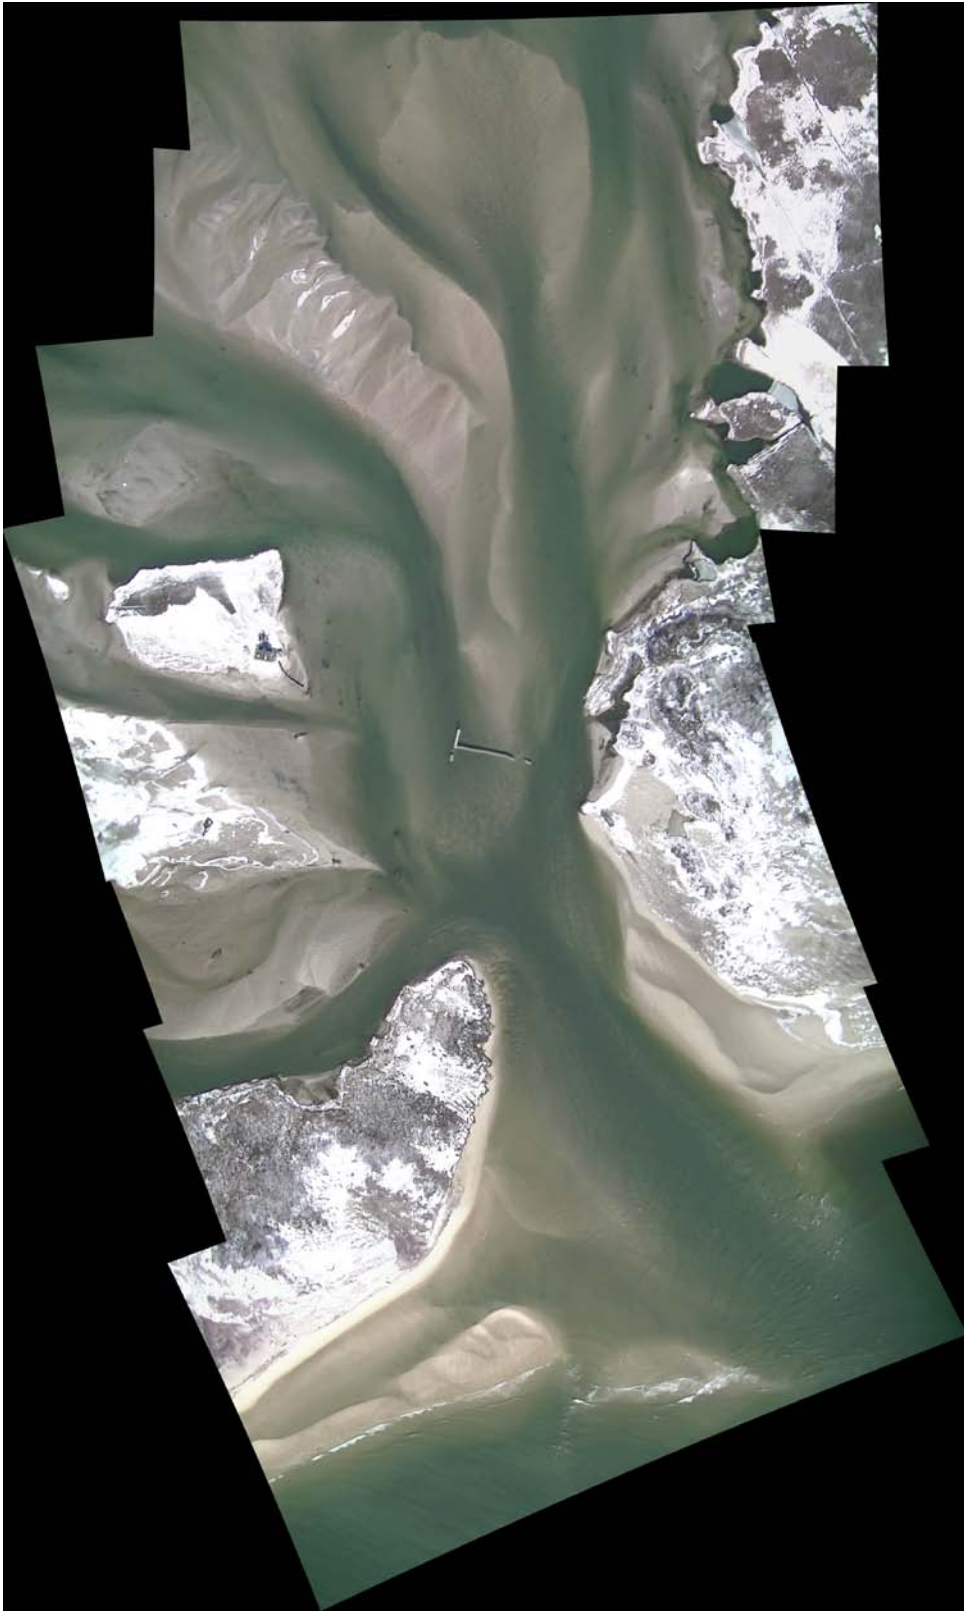
Figure 4. A mosaic of video snapshots of the inlet taken on January 27, 2013 by C. Flagg and D. Richards.

For the flight on January 27th, a video camera was fixed to the plane so that it looked straight down providing photos with minimal spatial distortion and from which one can make direct measurements. A mosaic of video snapshots (courtesy of Mark Lang) taken of the inlet from a height of 2000 feet is shown in Figure 4. To get a scale, one can use the remnants of the Old Inlet dock that measures about 52 meters from the cross of the “T” on the northwest end to the last piece of the dock to the southeast. If we use that as a scale, the narrowest part of the inlet is about 85 meters across while the deepest part of the channel, marked by the darkest colors, appears to be about 25 meters across. The narrowest part of the channel to the west is also about 25 meters wide while the channels to the northeast, although not that well defined, vary from 10 to 20 meters wide. The flood delta shows several lobes and channels, and it is clear that some sand deposits are now above water, since there is white snow evident in many places that in the past were under water. At the ocean end of the inlet, the light colored sand shows quite a bit of shoaling to the west and even a small bar forming along the eastern edge of the main channel.

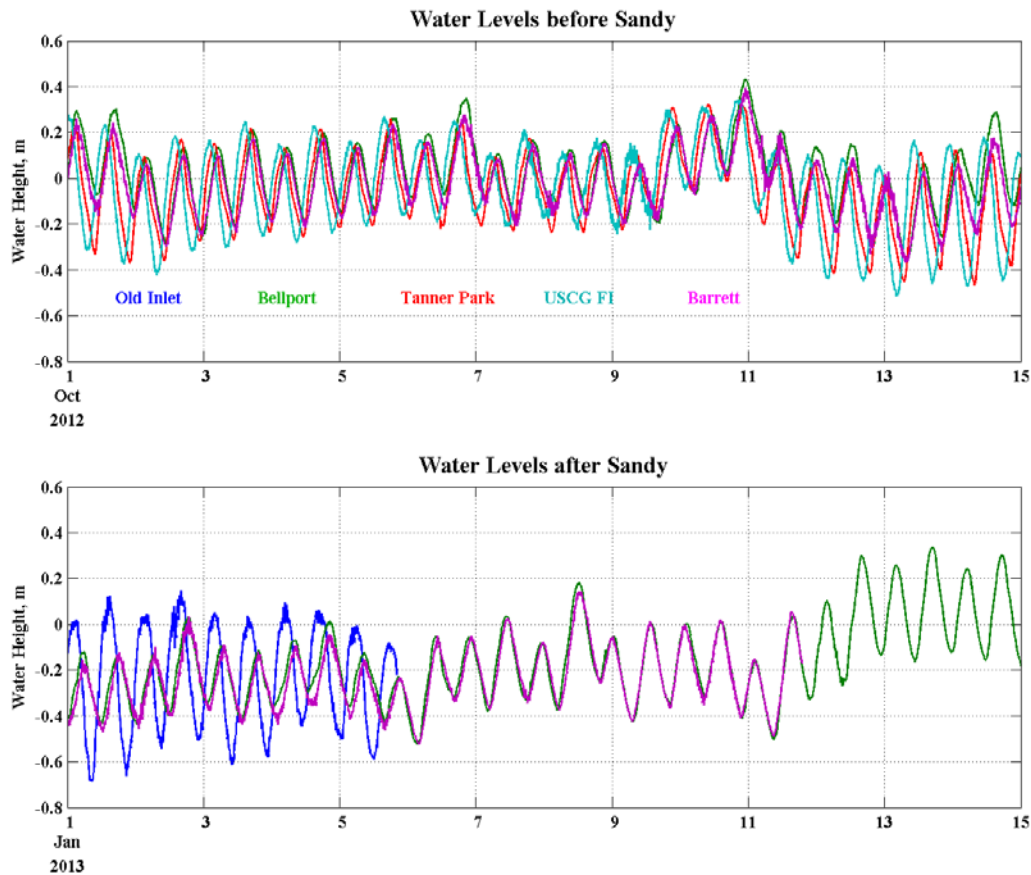
Figure 5. Water levels before and after super storm Sandy and the breach at Old Inlet.

A more graphic display of the similarity of the tide range at the sites before and after the opening of the breach is given in Figure 5, which shows the water level records for two 14-day periods. The Bellport and Barrett Beach records are essentially identical before and after the breach, and it is clear that the general tide ranges have not changed. While it is not shown in this figure, the constancy of the tide

range continues to the end of the Bellport record. In this figure the tidal range at the dock at Old Inlet (blue) is larger than that at Bellport. This was a recent development that occurred as a result of the late December storms and indicates that there is reduced transmittance between the inlet and Bellport Bay.

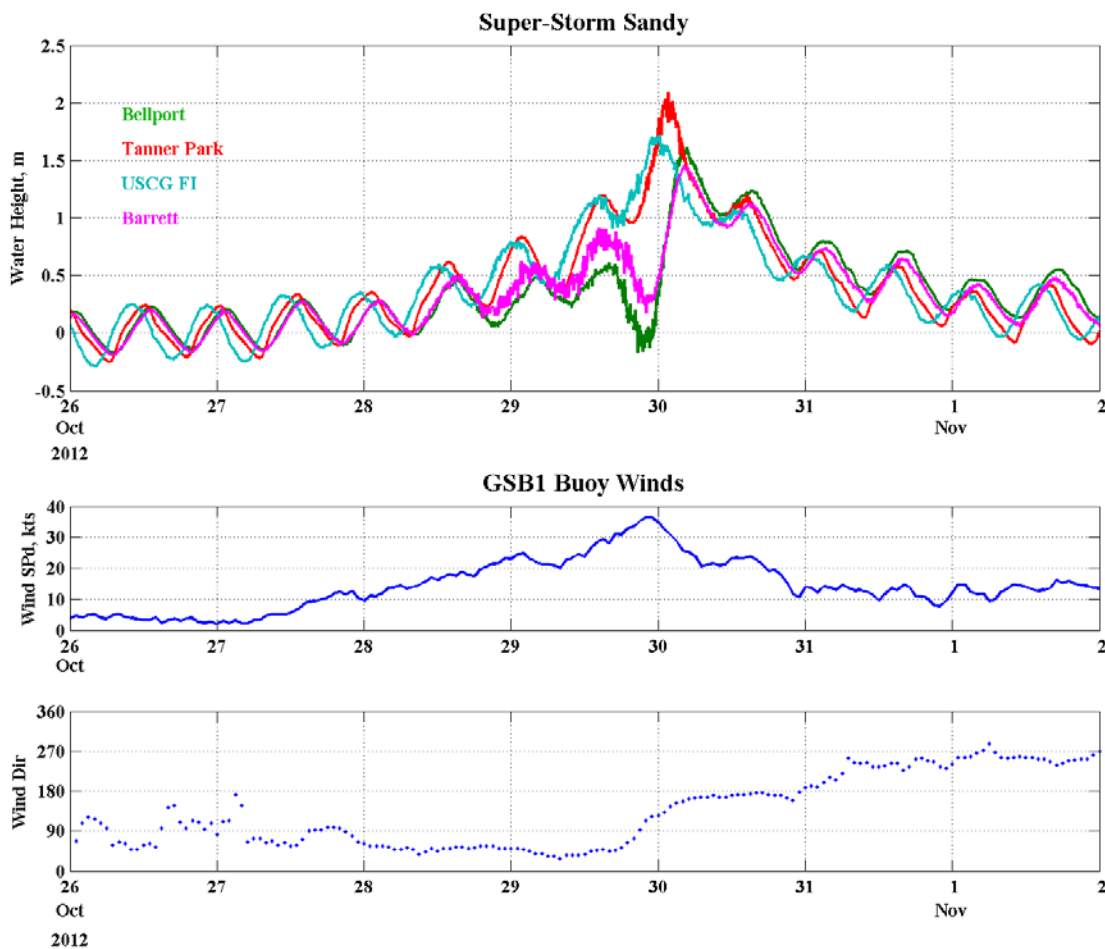
Figure 6. Water level records from sensors deployed during super storm Sandy and the wind speed and direction from the GSB1 buoy.

The addition of the water level record from the pier at Barrett Beach confirms the amount of storm surge in the eastern end of Great South Bay reported earlier, Figure 6. Barrett Beach is located about half-way between Bellport and the Fire Island USCG base, and so one might expect it to indicate a surge half way between the two stations. Figure 6 shows the records from all four instruments deployed at the time of super-storm Sandy where it is clear that the Barrett Beach record looks more like Bellport than either of the more western locations. This suggests that the “pivot” point about which the water level rotates in the Bay is farther west of Barrett Beach, perhaps off Islip; thus, points west of Islip can expect high water during strong east winds, while the eastern half of the bay experiences an initial drop in water level.

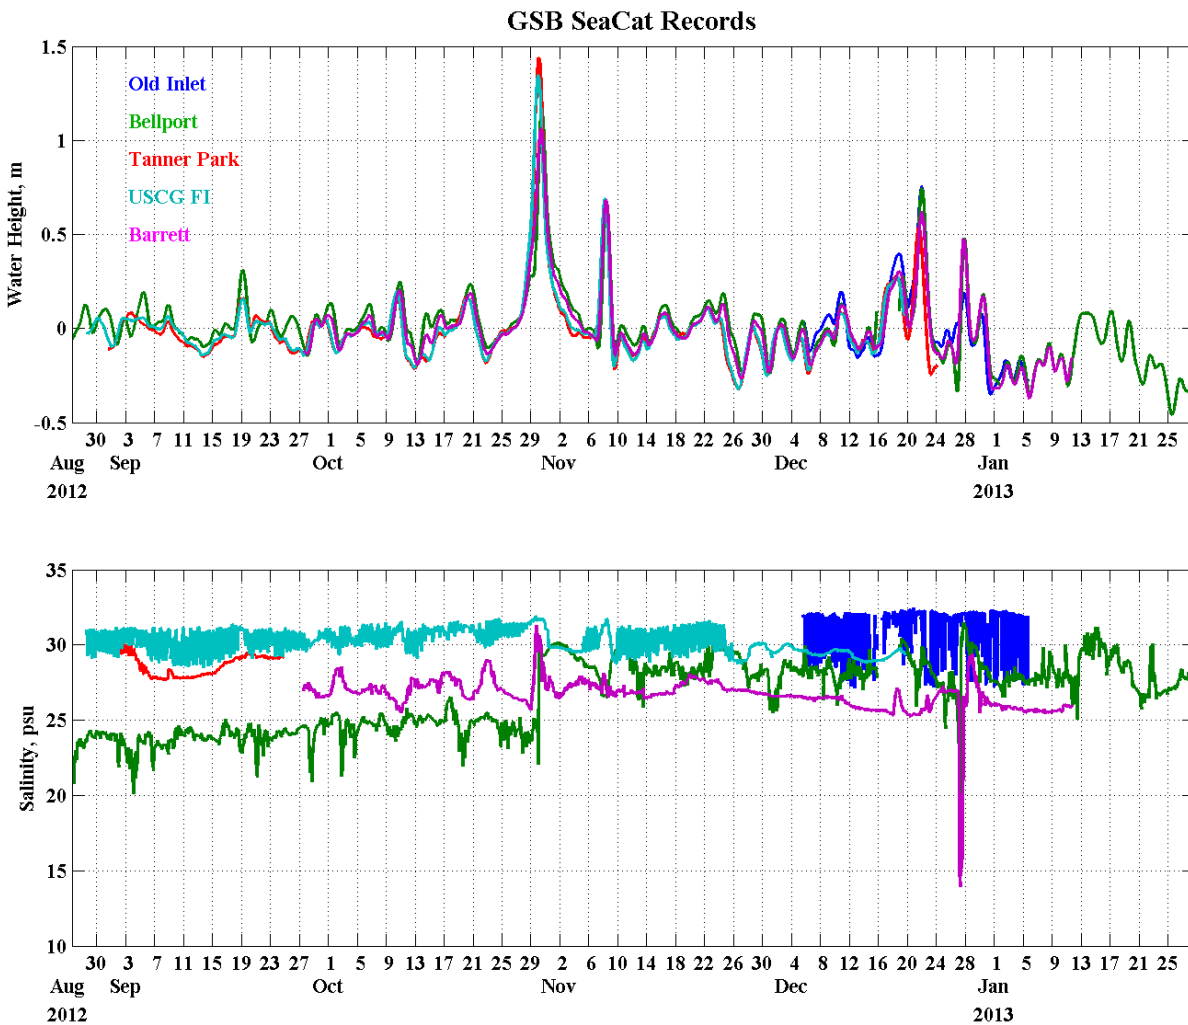
Figure 7. Results from the sensors arrayed around the Bay. The top panel shows the low-passed water level records from all five sites while the bottom panel shows the salinity records.

loads of any of the open water reaches of the larger Bay. It also had one of the lowest salinities at around 24 psu (practical salinity units). Salinity is not the same as either nutrients or coliform, but there is vastly less of either in the ocean waters just offshore of Fire Island; thus, increased salinity is an indicator of shorter residence times and improved water quality. As Figure 7 shows, there was a dramatic increase in salinity in Bellport Bay immediately after the inlet opened, and it has remained significantly higher ever since, averaging some three to four psu higher than its historic norm. Note that the salinity at Barrett Beach, which used to be higher than Bellport, is now significantly lower. Sometimes storms lower the salinity in Bellport Bay quite noticeably as fresh water is drained from Carmans River, Beaverdam Creek and directly from shore runoff. Sometimes the fresh water impact is dramatic as it was on December 27th during a torrential rainfall event. At other times, when there is an extended period of east winds that cause an increased influx of ocean water through the inlet, salinities in the Bay can reach nearly oceanic numbers.
